Intel[®] Pentium[®] III Processor Specification Update

Release Date: December 2001

Order Number: 244453-036

The Pentium[®] III processor may contain design defects or errors known as errata which may cause the product to deviate from published specifications. Current characterized errata are documented in this Specification Update.

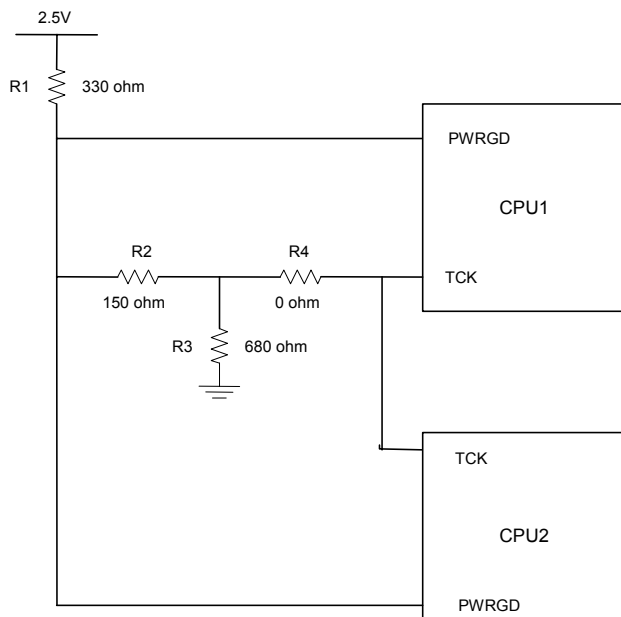
Pentium® III Processor with 512KB L2 Cache Platforms Workaround

In addition, the example workaround circuits shown do not support production baseboard test methodologies that require the use of the processor JTAG/TAP port. Alternative workaround solutions must be found if such test capability is required.

Assumes the inputs to the CPU_PWRGD are open collector signals that are Wire-ANDed together

- The example workaround circuit assumes that the PWRGD inputs into the processors are open collector. Tying the PWRGD inputs together in a Wired-AND fashion allows each processor to receive PWRGD at the same time but at the latter of the 2 separate PWRGD assertions. If separation of the PWRGD inputs to each processor is required, extra circuitry will be required.
